The Road Inventory of Hakalau Forest National Wildlife Refuge Hilo, HI

Prepared By:
Federal Highway Administration
Central Federal Lands Highway Division
April 2013

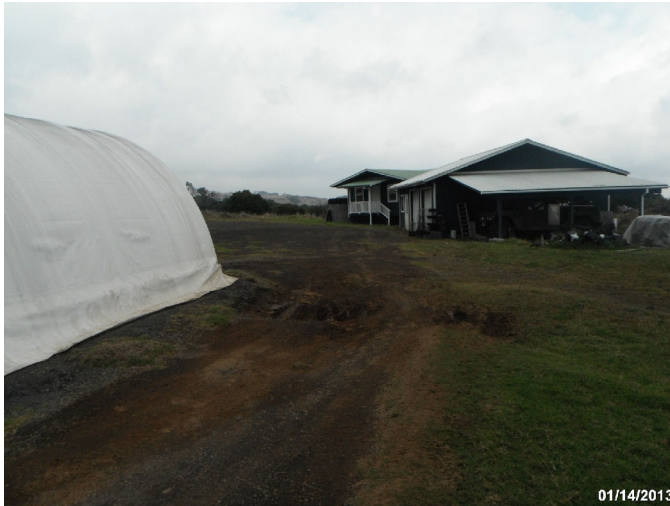
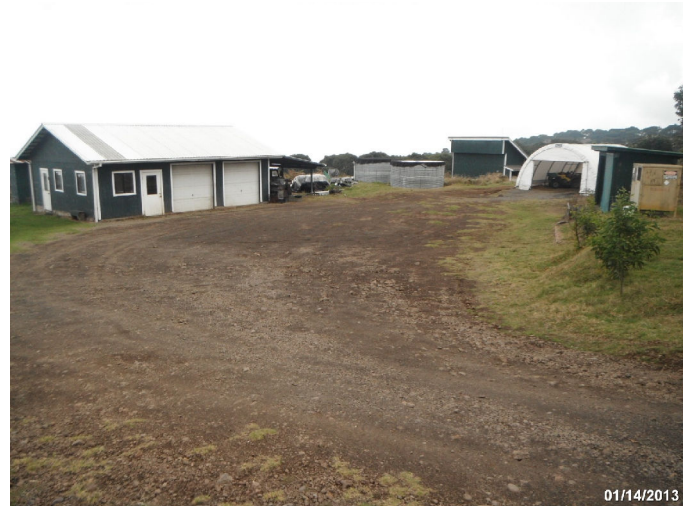
Asset Number	Area (Sq Ft)	Spaces	Condition	Surface Type	Cost to Improve	Inspection Date	Current Replacement Value
10042170	8121	4	Poor	Gravel	\$12,000	01-14-2013	\$53,800

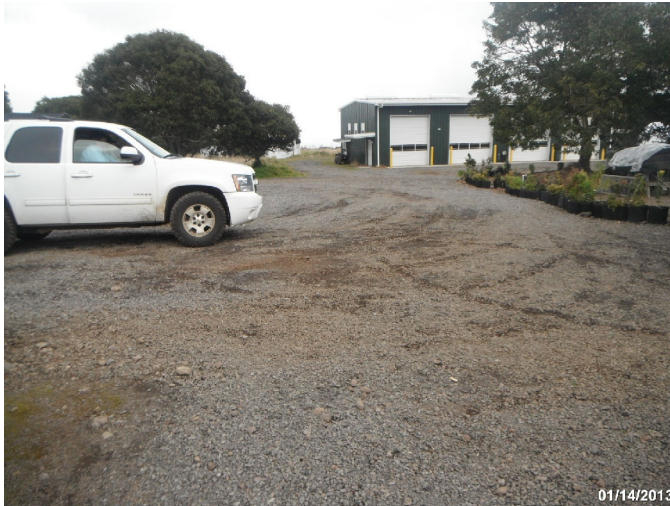
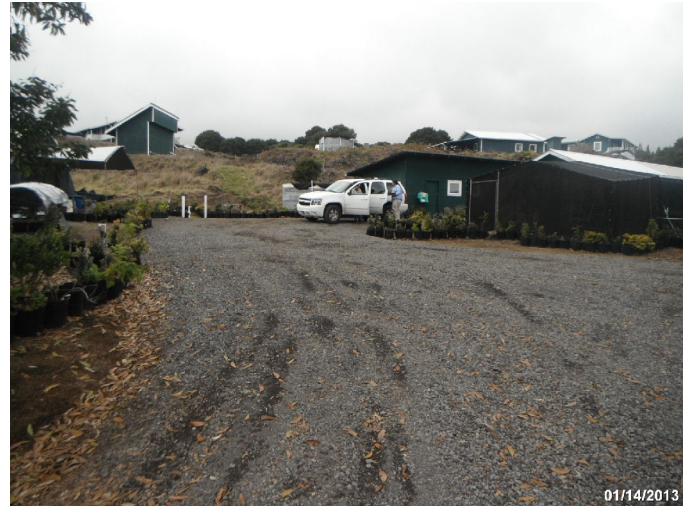
Asset Number	Area (Sq Ft)	Spaces	Condition	Surface Type	Cost to Improve	Inspection Date	Current Replacement Value
10042171	3528	5	Good	Gravel	\$700	01-14-2013	\$23,400

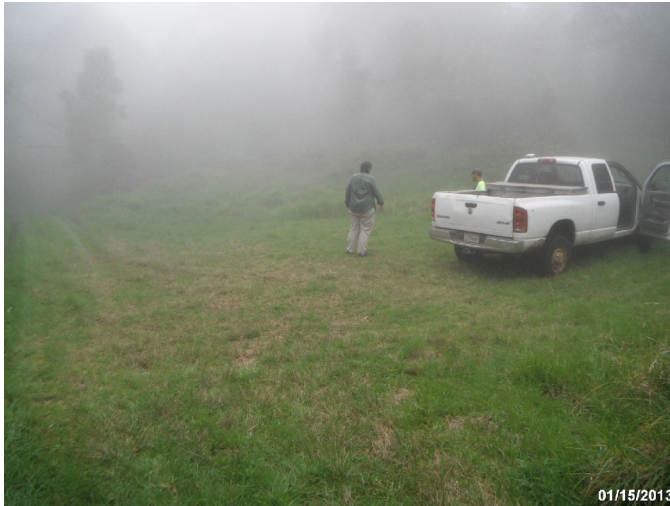
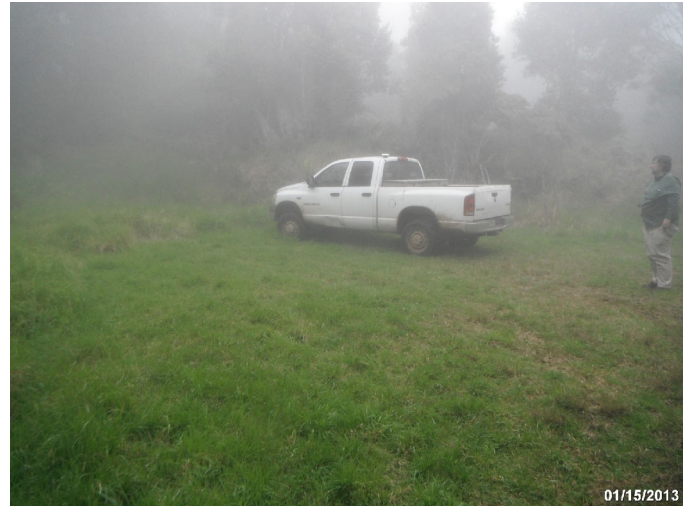
Asset Number	Area (Sq Ft)	Spaces	Condition	Surface Type	Cost to Improve	Inspection Date	Current Replacement Value
10053544	2764	6	Good	Native	\$600	01-15-2013	\$7,900

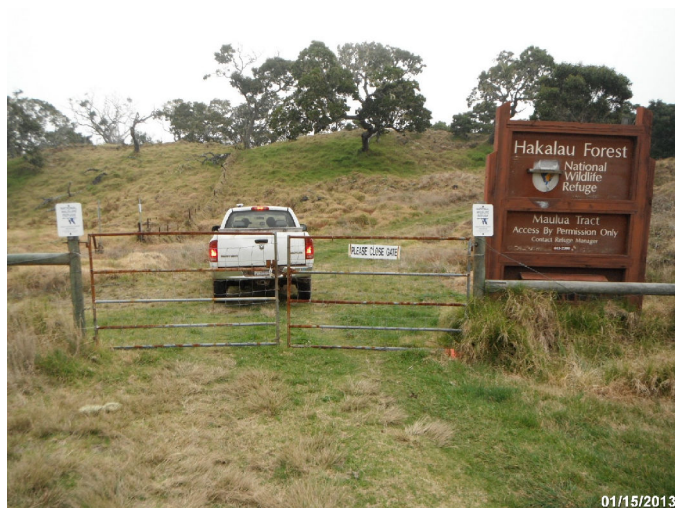
Photo: HAFO_C4_0913 Route: 100-001-0.01
Metal Open Rail Gate
Asset# NA

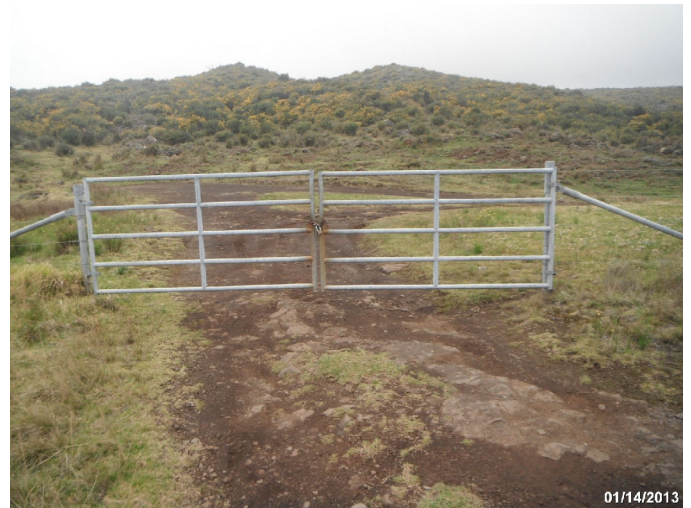
Photo: HAFO_C4_0873 Route: 101-001-0.01
Metal Open Rail Gate
Asset# NA

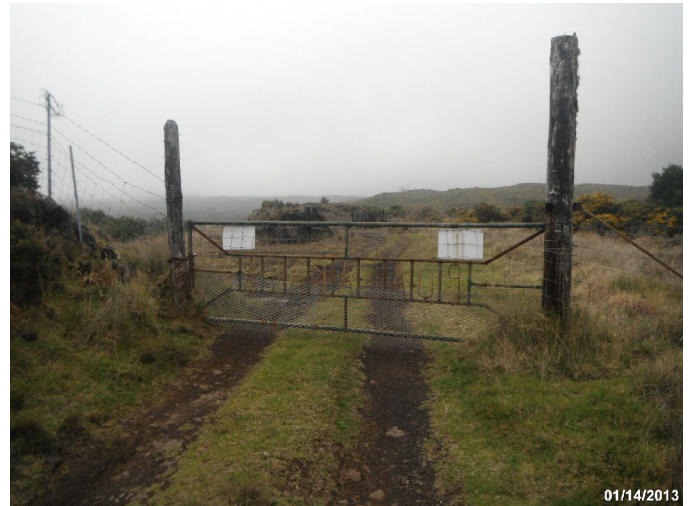
Photo: HAFO_C4_0872 Route: 101-002-0.15
Metal Open Rail Gate
Asset# NA

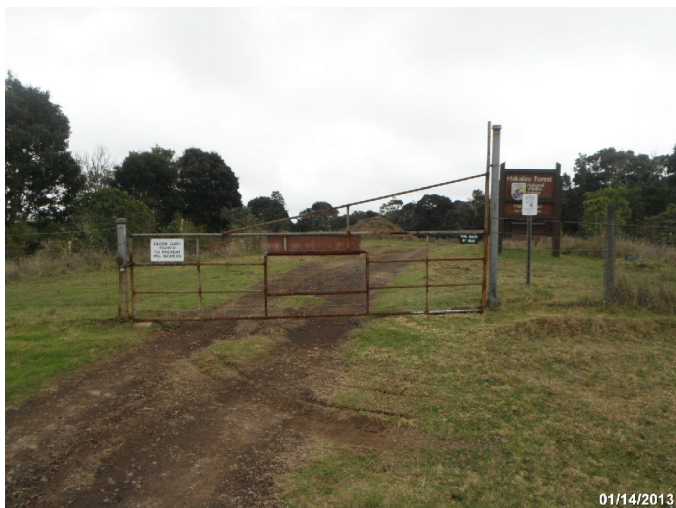
Photo: HAFO_C4_0845 Route: 102-002-0.27
Metal Open Rail Gate
Asset# NA

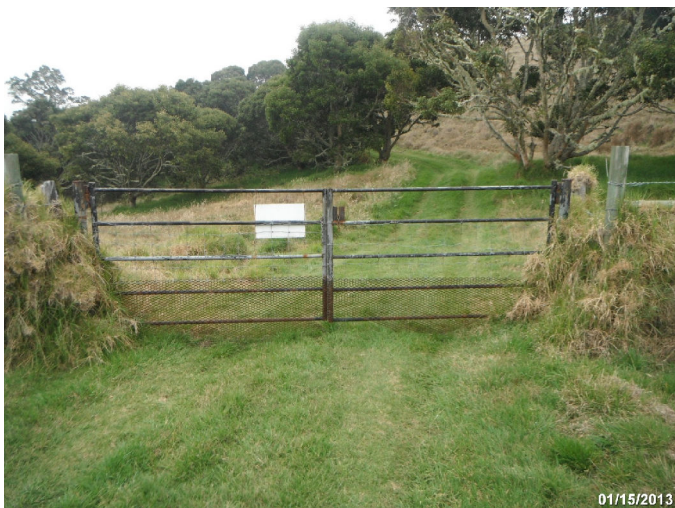
Photo: HAFO_C4_0896 Route: 400-002-1.14
Metal Open Rail Gate
Asset# NA

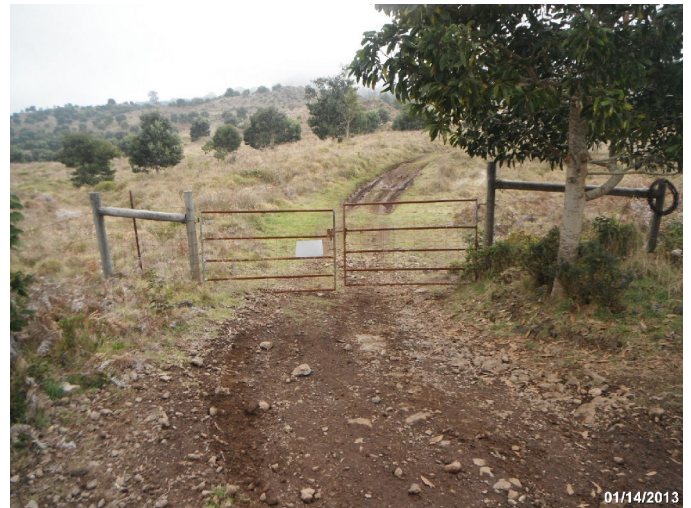
Photo: HAFO_C4_0862 Route: 400-006-4.31
Metal Open Rail Gate
Asset# NA

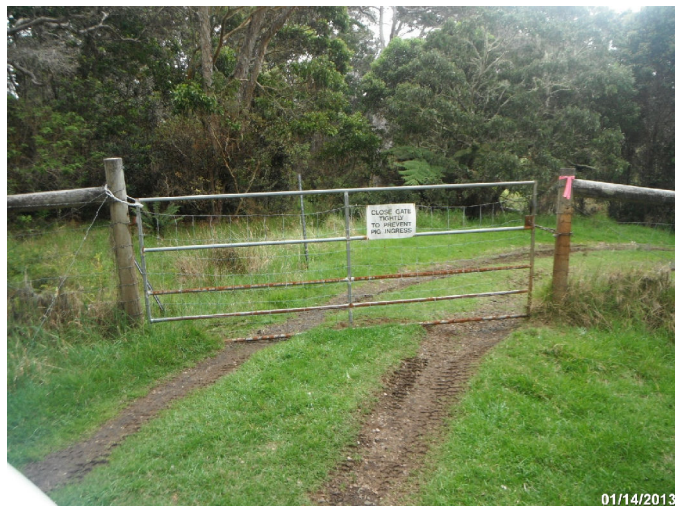
Photo: HAFO_C4_0867 Route: 401-001-0.4
Metal Open Rail Gate
Asset# NA

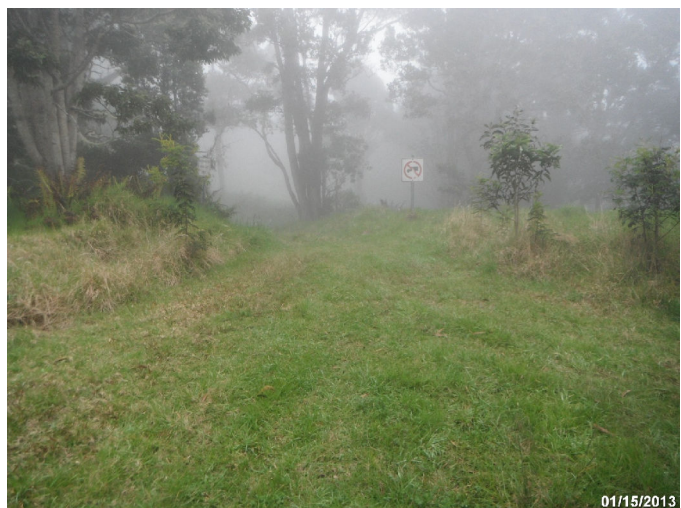
Photo: HAFO_C4_0923 Route: 600-001-0.0
Obstacle Location of Freddy's Pond Road. #10002407
ATV trail that is too muddy to drive.

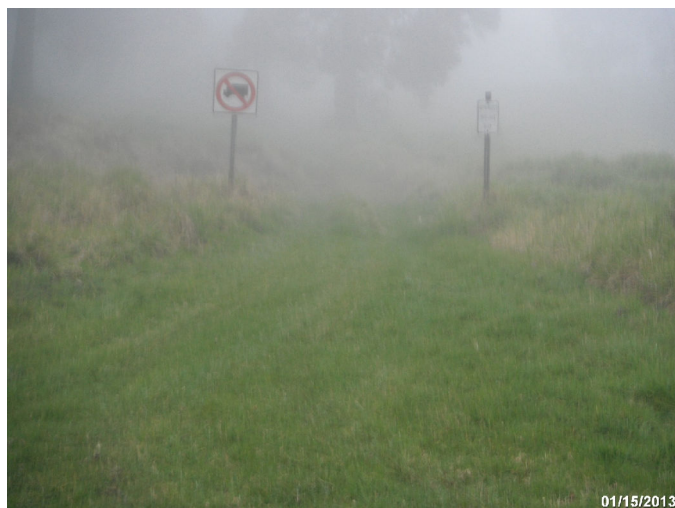
Photo: HAFO_C4_0926 Route: 600-001-0.0
Obstacle Location of Halfway Road. #10002406 ATV
trail that is too muddy to drive.

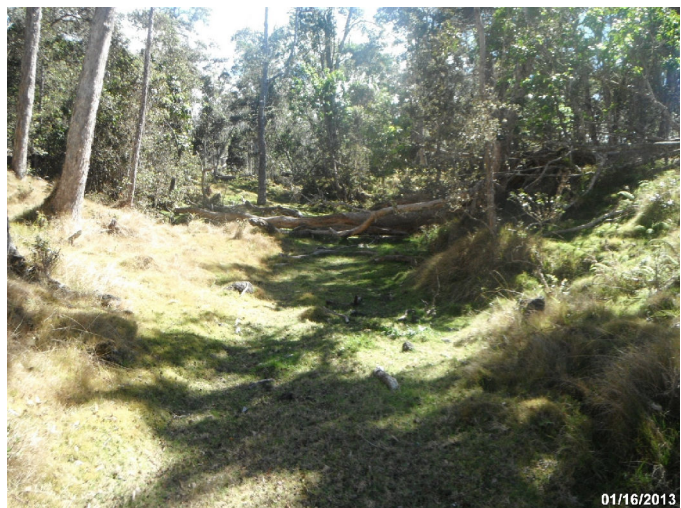
Photo: HAFO_C4_0956 Route: 600-001-0.5
Obstacle Location of Hookena Loop Road. #10001968
Tree down unable to access

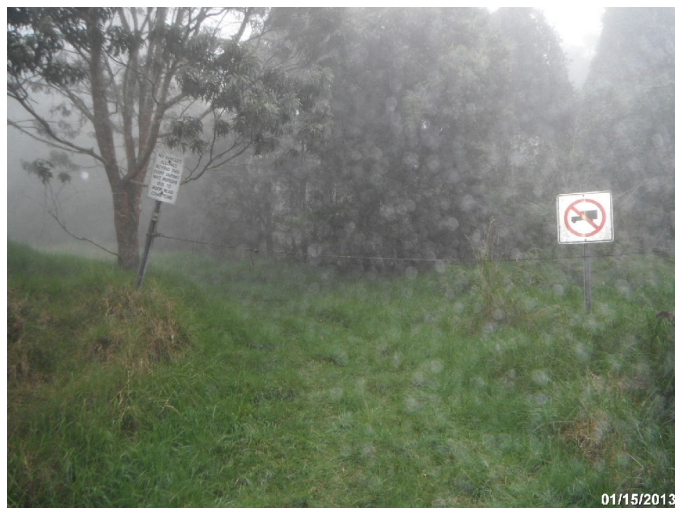
Photo: HAFO_C4_0919 Route: 600-001-3.11
Obstacle Location of Bottom Road. #10002408. ATV
trail that is too muddy to drive.
